NASA TECHNICAL
MEMORANDUM

NASA TM X-64788

ATM C&D PANEL/EREP COOLING SYSTEM
CONTAMINATION PROBLEM

By James G. Williamson
Astronautics Laboratory

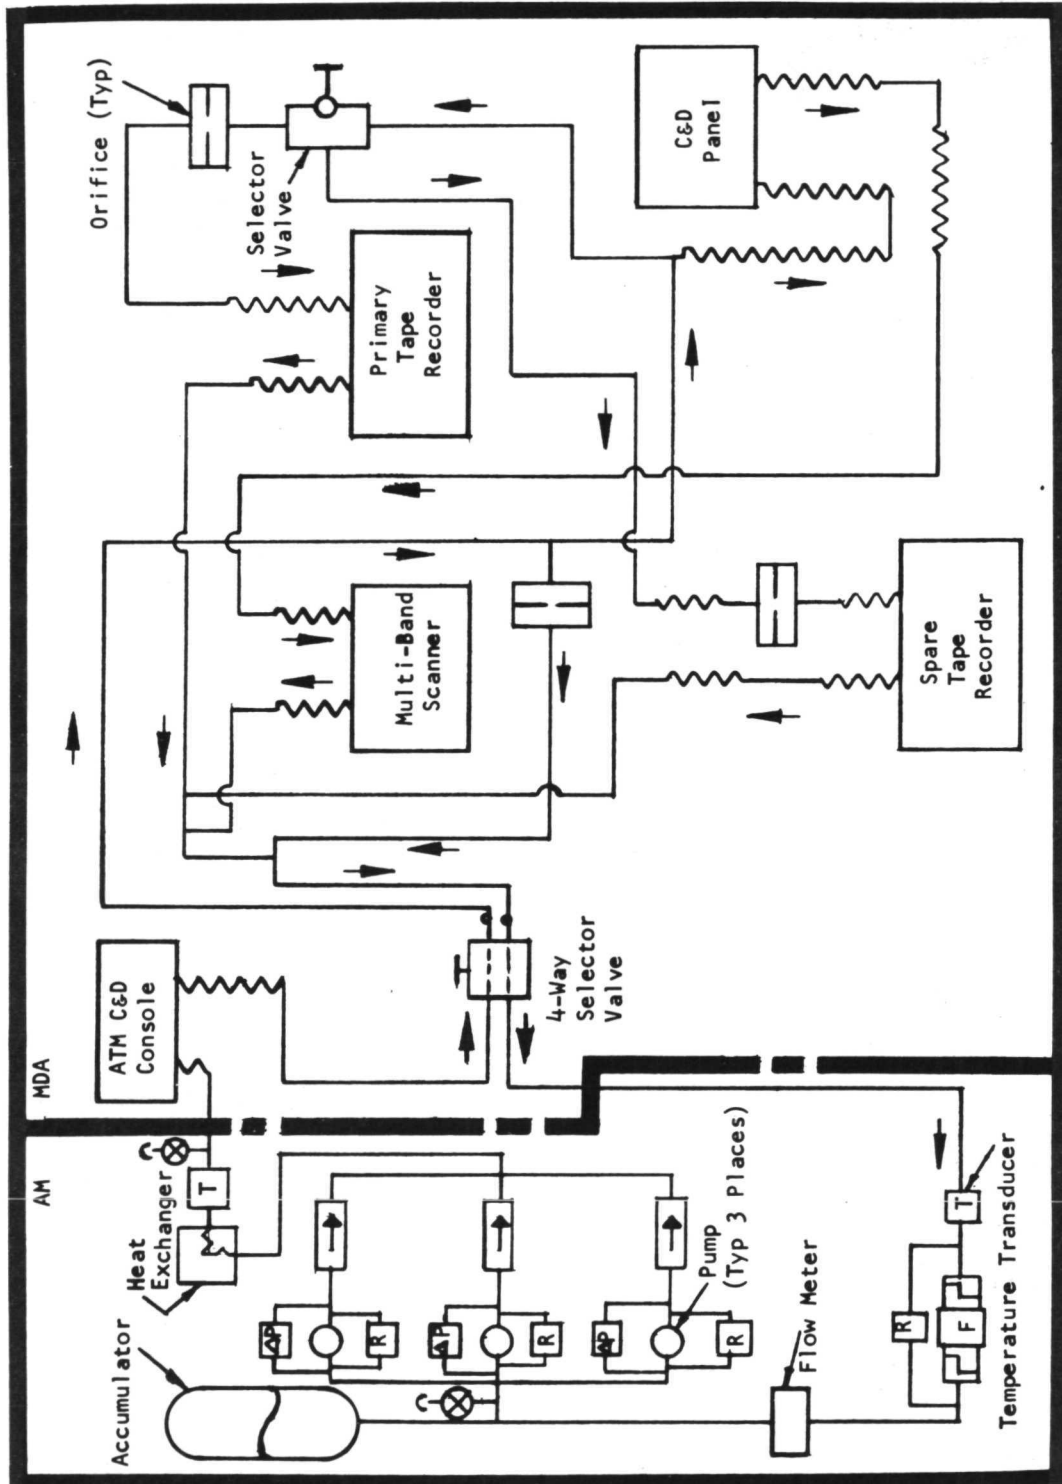
FIGURE 1 - SCHEMATIC OF ATM C&D PANEL/EREP COOLING SYSTEM

The Apollo Telescope Mount (ATM) Control and Display (C&D) Panel and Earth Resources Experiment Package (EREP) Cooling System provides cooling to the two components by circulating an inhibited water coolant. The ATM C&D panel system contains essentially pumps, valves, heat exchanger, filter, coldplate and necessary tubing. The EREP system consists of primary and secondary tape recorder coldplates, Control and Display coldplate and S-192 electronic package coldplate. The EREP is located in the Multiple Docking Adapter (MDA) and the remainder of the system is in the Airlock Module (AM). A schematic of this system is shown in Figure 1.

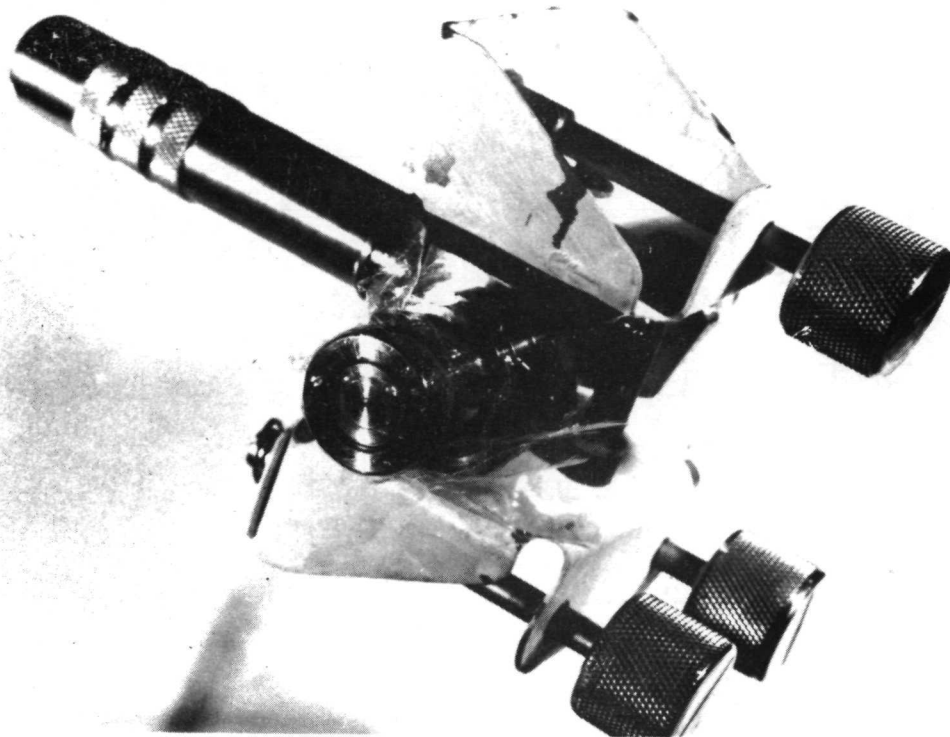
FIGURE 2 - FILTER ASSEMBLY

The system was installed in the Skylab and was refilled with coolant for approximately 4 months during which it had some 438 hours of operation. The filter (S/N 9) was removed from the system in January 1973 and was found to be relatively clean. The filter had actually been in the system for 14 months, about 10 months before being moved to KSC. Figure 2 shows a complete filter assembly.

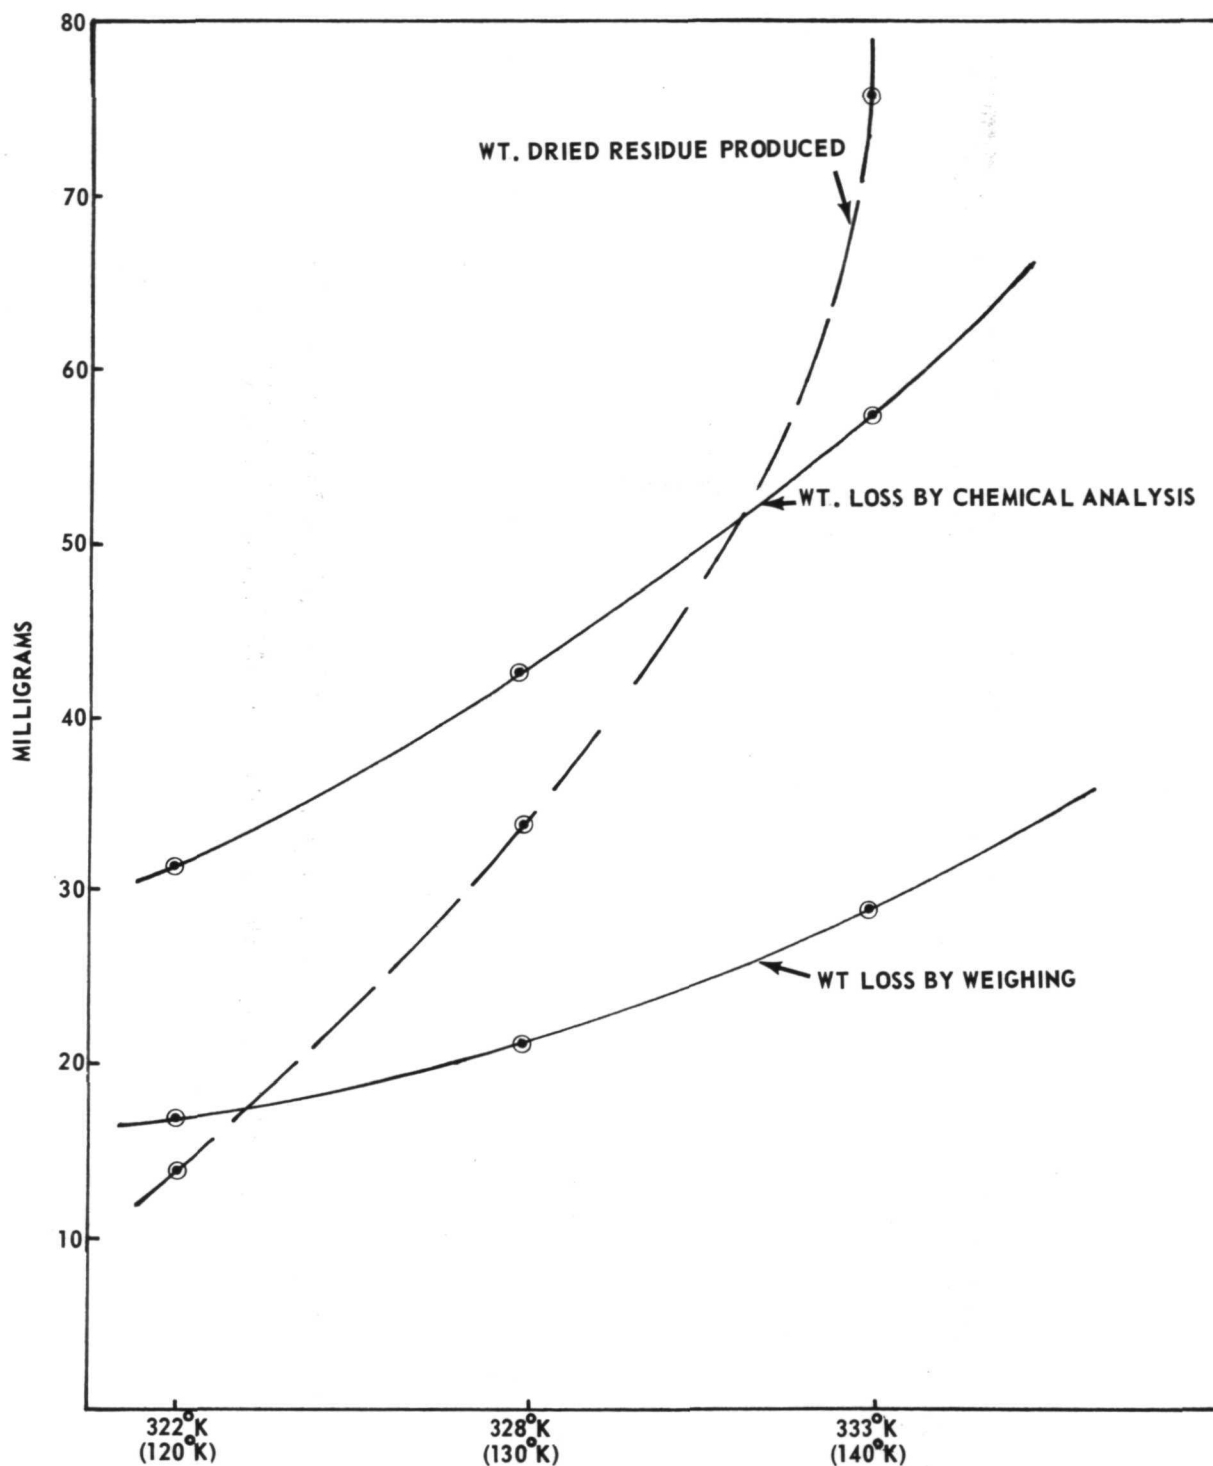
FIGURE 7 EFFECT OF EXPOSING 6061 ALUMINUM IN TYPE 1 SOLUTION FOR 15 HOURS AT VARIOUS TEMPERATURES

as shown in Figure 6. Table I and Figure 7 give the results of these tests. The spectrographic analysis of the residue from the solution formed at 333°K (140°F) with the aluminum specimens showed the following:

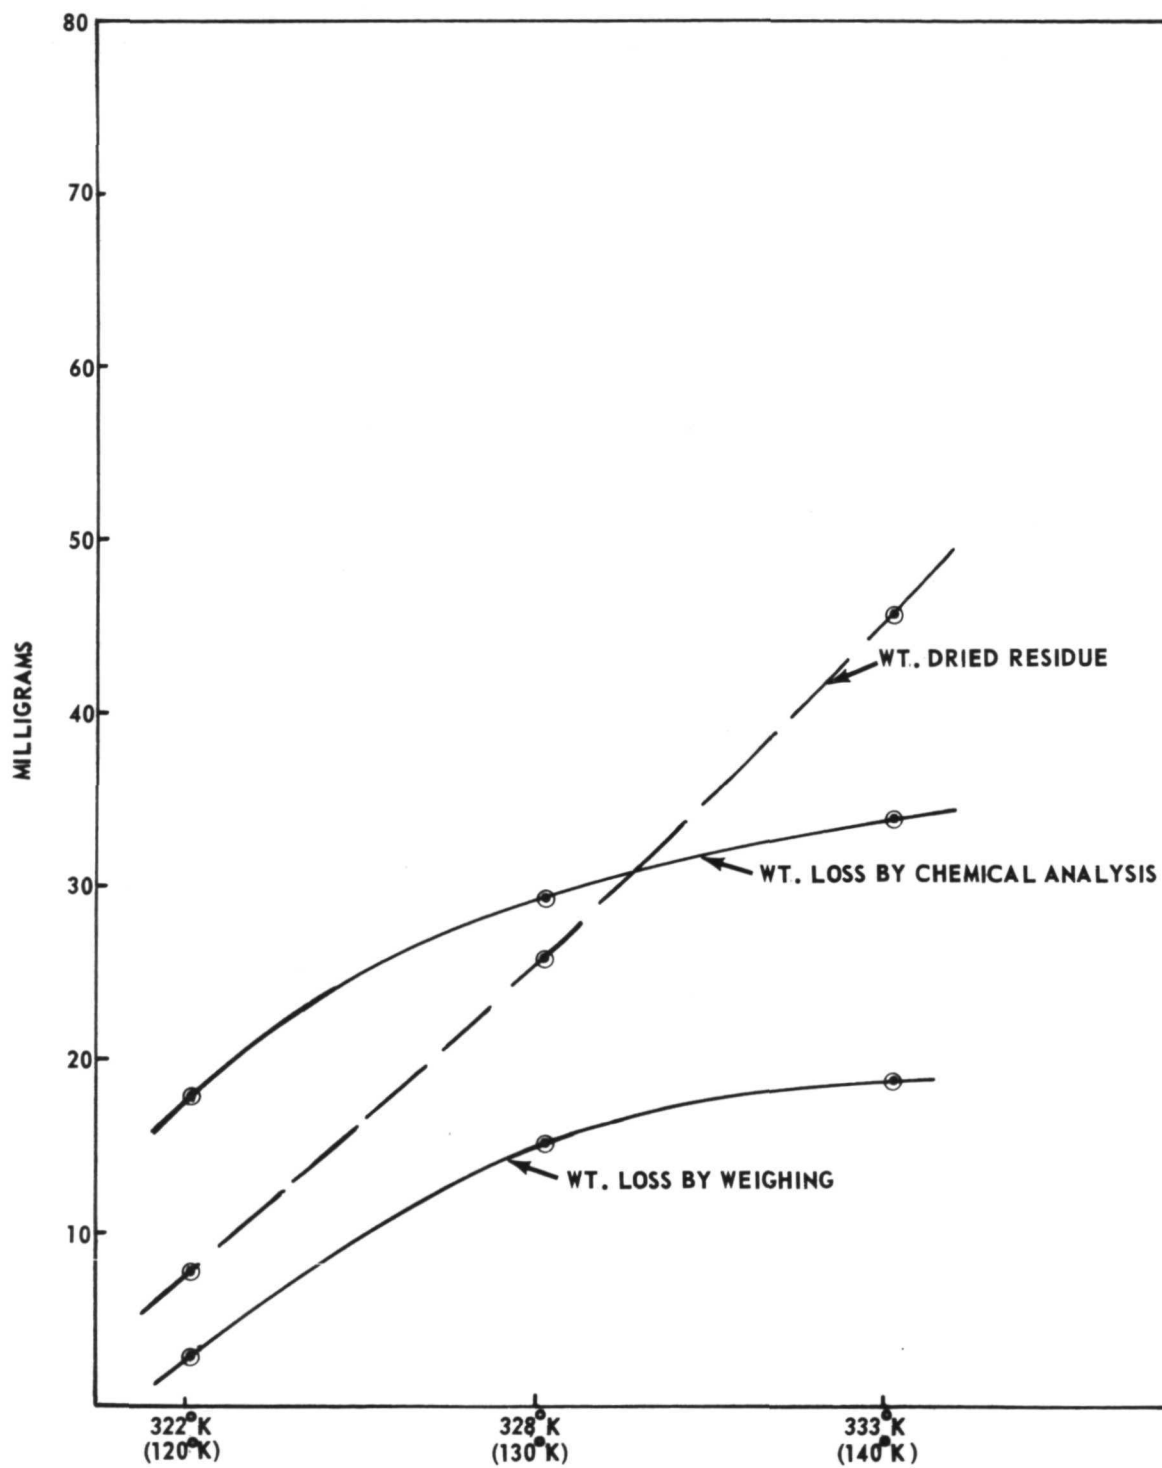
FIGURE 8 EFFECT OF EXPOSING 6061 ALUMINUM IN TYPE 1 SOLUTION FOR 4 HOURS AT VARIOUS TEMPERATURES

Two other series of tests were made identical to the above test except the times were reduced to 4 hours and 2 hours. The specimens were cleaned and etched prior to these tests. Tables II and III and Figures 8 and 9 show the resulting weight loss of these specimens. The rate of attack is reduced with time even at the higher temperatures, as shown in Figure 10.

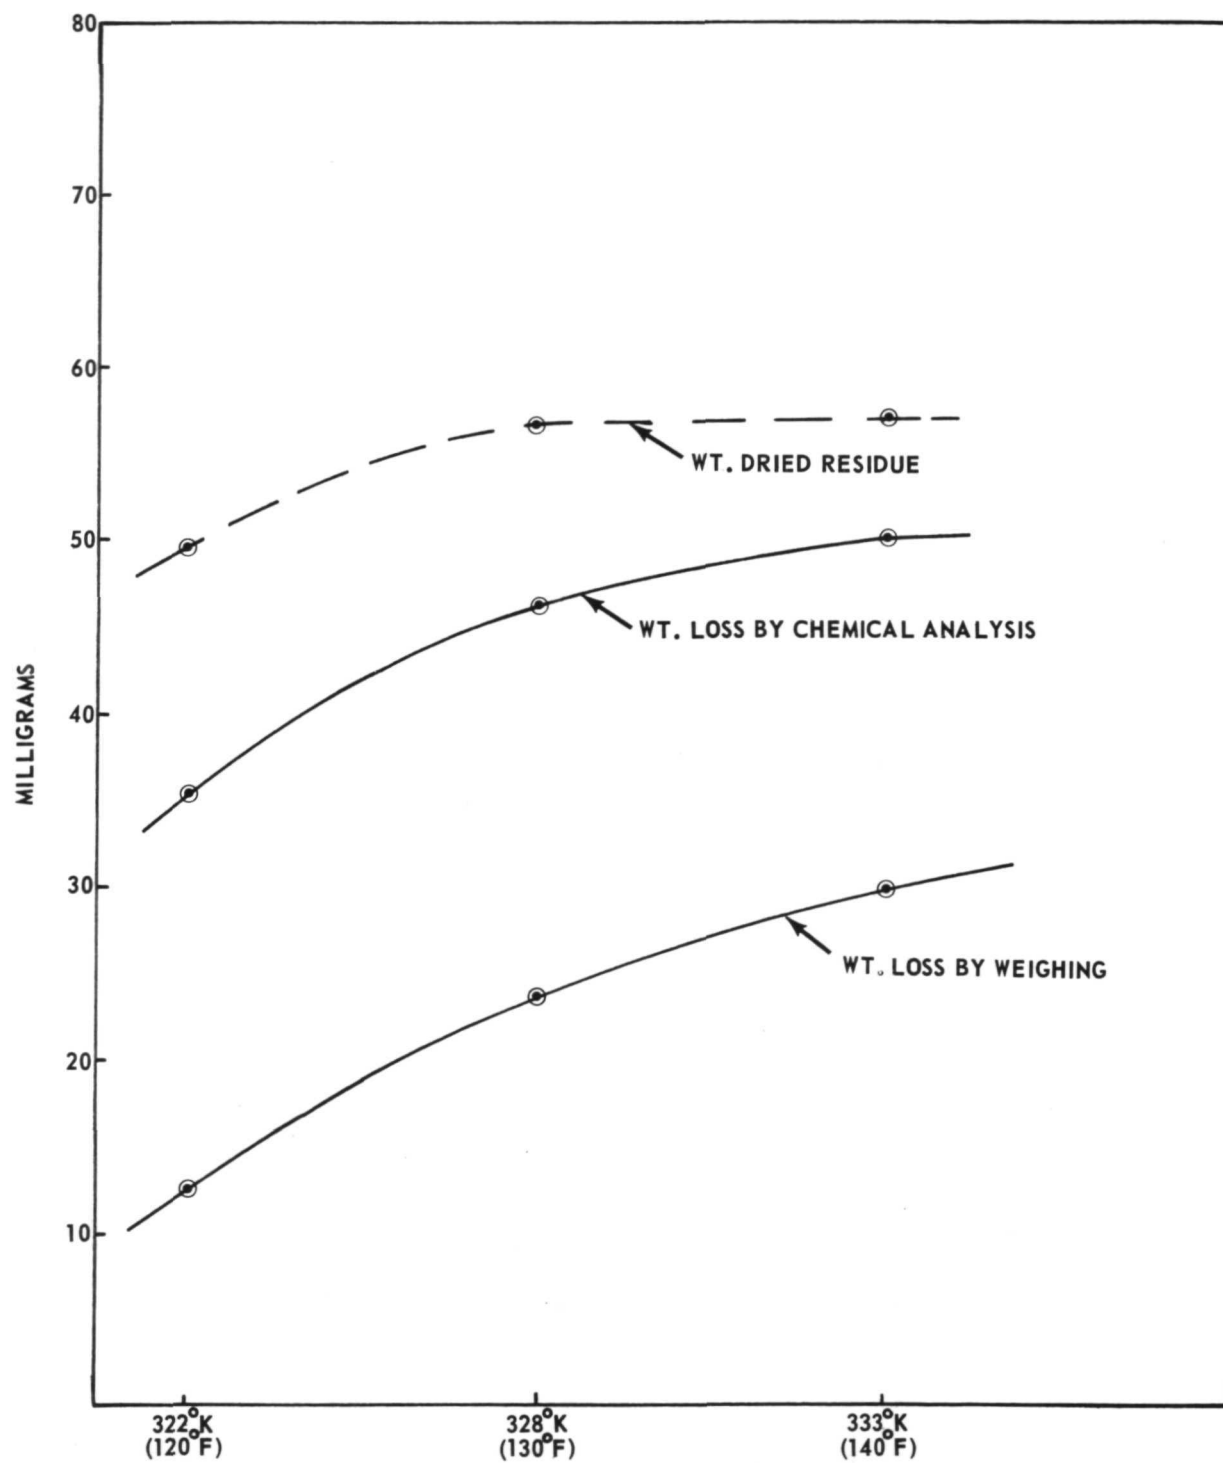
FIGURE 11 EFFECT OF EXPOSING SIMULATED EREP COLDPLATE IN TYPE 1 SOLUTION FOR 4 HOURS AT VARIOUS TEMPERATURES

The results of these studies are shown in Table IV and Figure 11. The residue produced was not significantly greater at 333°K (140°F) than that produced with a much smaller (6.5 times less) amount of aluminum. However, it can be noted that the temperature had much less effect on the amount of residue produced than it did with the studies in which a smaller area of aluminum (390 sq. cm) was used. The studies using the smaller amount of aluminum (390 sq. cm) produced 7.8 mg at 322°K (120°F) while the tests using the larger amount of aluminum produced 49.5 mg at the same temperature or 6.35 times more. Since the area of aluminum was 6.5 greater, this would be the expected result. However, the larger amount of aluminum produced only 56.8 mg. of residue at 333°K (140°F) or only 1.146 times that produced at 322°K (120°F) under the same conditions. Using the smaller amount of aluminum, 5.78 times more residue was produced at 333°K (140°F) than was produced at 322°K (120°F).
